## AN INNOVATIVE BUILDING ENCLOSURE RETROFIT FOR AN EXISTING SOLID MASONRY DOUBLE WYTHE BRICK HOME IN A COLD CLIMATE

P. Christopher Timusk	George Brown College	ctimusk@georgebrown.ca
Steffanie Adams	George Brown College	sadams@georgebrown.ca

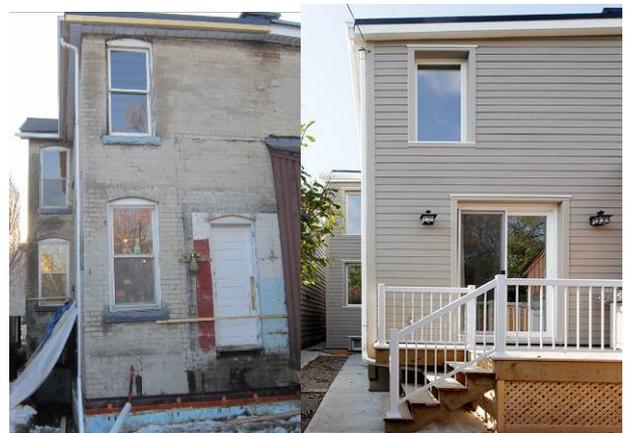
Fig 2: 111 Russett Pre-Retrofit (left) and Post-Retrofit (Right)

The retrofit needed to improve the energy efficiency through increasing the overall thermal resistance of the exterior wall assemblies, as well as the air tightness of the walls to minimize uncontrolled air leakage. The assembly also needed to provide a very high degree of fire resistance due to the close proximity to the adjoining building. All this needed to be achieved using locally available building materials, with an assembly that was easily installed by non-specialized trades, and at a price competitive with the least expensive systems on the market, which was an Exterior Insulation Finishing System (EIFS).

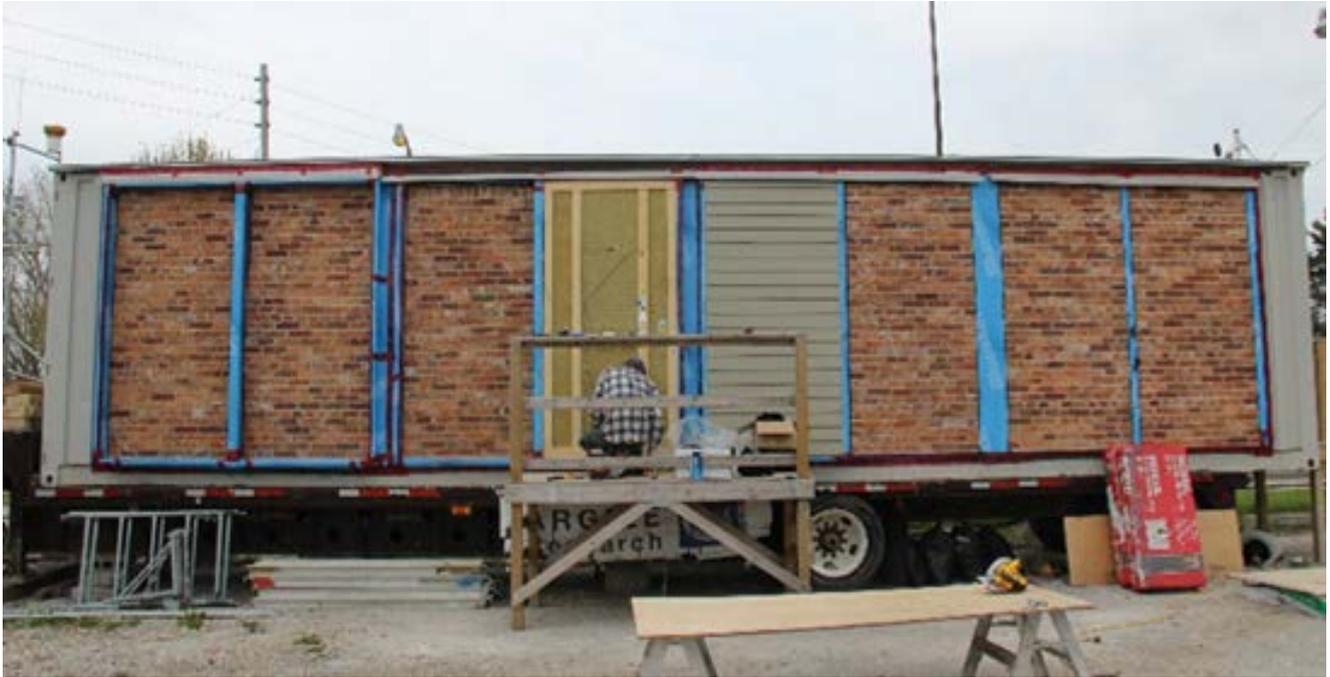
Fig 3: Test walls in Natural Exposure Test Hut

After the first mock-up, a pair of 4'x8' (1.2m x 2.4m) matching wall assemblies were installed in our natural exposure test facility (test hut). One wall had east exposure (the direction of the prevailing wind and thus maximum wind driven rain), and one west. These assemblies were part of a larger study with a total of 8 pairs of walls, all of which incorporated a solid masonry, double-wythe, reclaimed historic brick base wall with a lime based mortar, assembled by an expert bricklayer. The walls were instrumented with relative humidity and temperature sensors, embedded wood surrogate moisture content and temperature sensors (duff gauges), and monitored for a whole year. Data was logged via a Campbell Scientific data logger and multiplexer. The inside of the test hut was conditioned to a constant 20°C and 40% relative humidity (RH), and the outside conditions were monitored with a weather station mounted on the test hut roof.

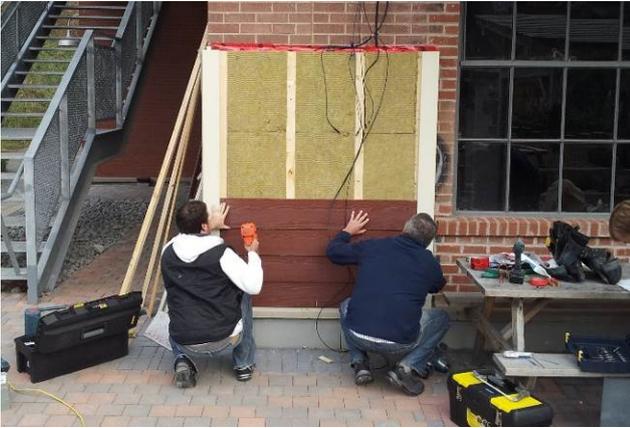
Fig 4: Small scale field test

The constructability of the assembly was assessed with the first small-scale mock-up, which was installed on the corner of a vintage building. The assembly was also instrumented and monitored, to ensure durability.
